Manhole Inspection Summary

Manhole # S07AA2025MH

Insp Date: **9/18/06 3:21 PM**

Location Address: **5841 WESTERN RUN DRIVE**

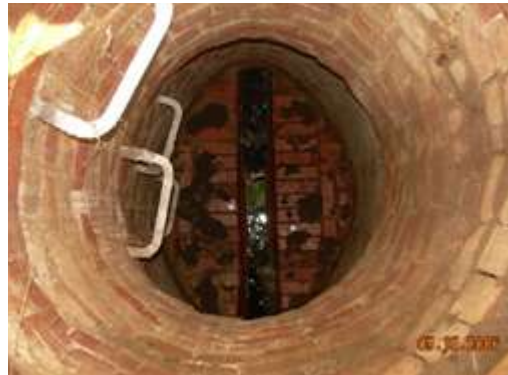
Top View

Frame offset. Adjustment, Corbel, and Barrel infiltration. Evidence of surcharge - Bench debris.

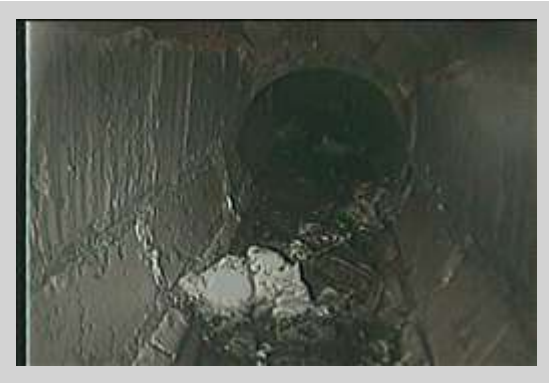
8 in. Circular Gravity Sewer Pipe Out @ 12 O'Clock

Deposits: ☐ None ☒ **Mud** ☐ Sludge ☒ **Debris** ☐ Grease

Silt Depth: **1** (in.) Deposits Extent: **Light**

Infiltration: **Evidence** Pipe Seal Cond: **Cracked**

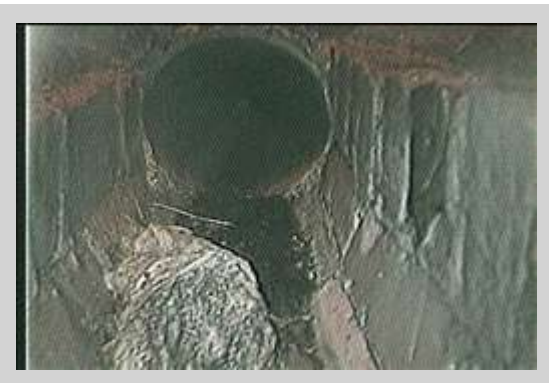
8 in. Circular Gravity Sewer Pipe In @ 6 O'Clock

Infiltration: **Evidence** Pipe Seal Cond: **Unknown**
